Post-additive manufacturing machining operations applied to Ti6Al4V biomedical alloy

Semi-finishing turning on AM Ti6Al4V

→ To design proper cutting parameters and prove the effectiveness of ***cryogenic cooling*** in reducing the tool wear and increasing the surface integrity

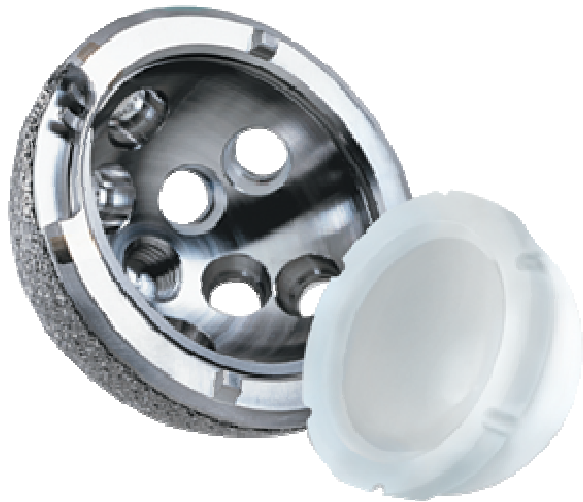
Motivation /1

- ➔ **Additive Manufacturing (AM) technologies** have been increasingly adopted to produce near-net-shape metal parts in small batches, i.e. in the biomedical field to produce tailored surfaces with osseointegration capabilities
- ➔ **Semi-finishing and/or finishing machining operations** are still required to obtain adequate geometrical tolerances and surface characteristics on functional surfaces

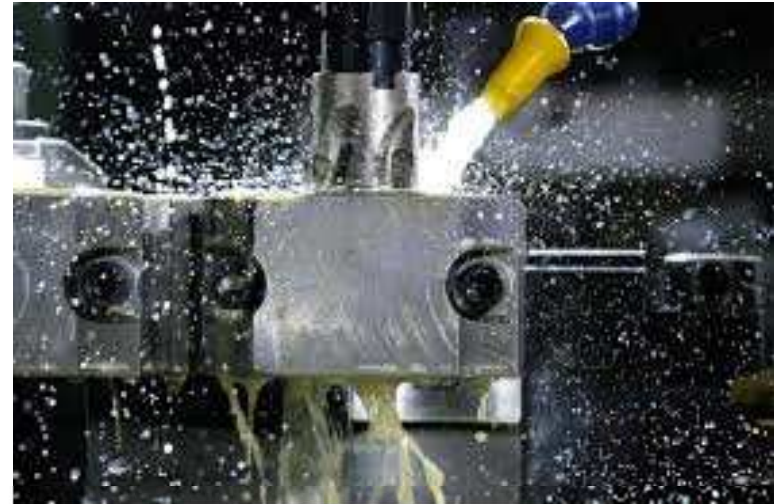
Motivation /2

- ➔ Machining operations are commonly carried out adopting standard lubricating strategies, i.e. oil mist, mineral and water emulsions
- ➔ Cleaning and sterilization of the surgical implants imply costly and time-consuming steps

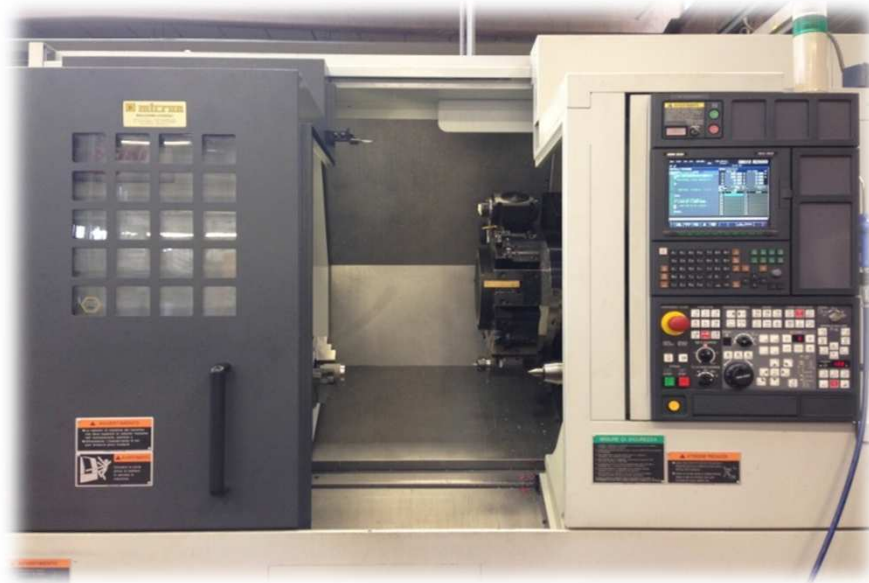
Semi-finishing turning tests

- Mori Seiki™ NL 1500 CNC lathe
- Semi finishing TiAlN coated tungsten carbide insert Sandvik® CNMG 120404SM GC 1105
- Conventional lubricated conditions: mineral oil and water emulsion supplied at 6 bar
 - ➡ VB fixed, 0.1 mm
 - ➡ Max cutting time, 15 minutes

Time length [min]	Cutting speed [m/min]	Feed rate [mm/rev]	Depth of cut [mm]
3-8-15	50	0.1	0.25
3-8-15	50	0.2	0.25
3-8-15	80	0.1	0.25
3-8-15	80	0.2	0.25

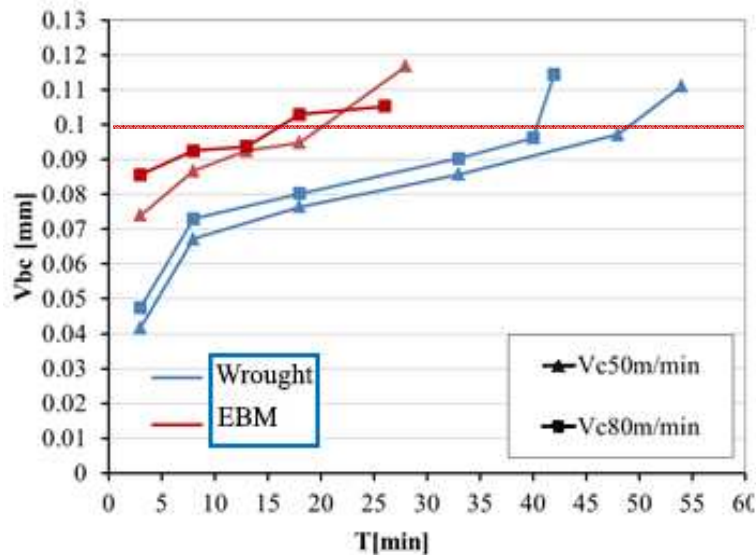
Wear analysis – EBM vs. wrought

- For both the wrought and EBM alloys, the effect of the cutting speed on the tool wear is negligible
- The feed rate plays the major role
- The time to reach the tool wear limit is more than 200% in turning the wrought Ti6Al4V than the EBM Ti6Al4V for both the cutting speeds
- The great amount of adhered material plays as a protection layer against the cutting speed rubbing effect

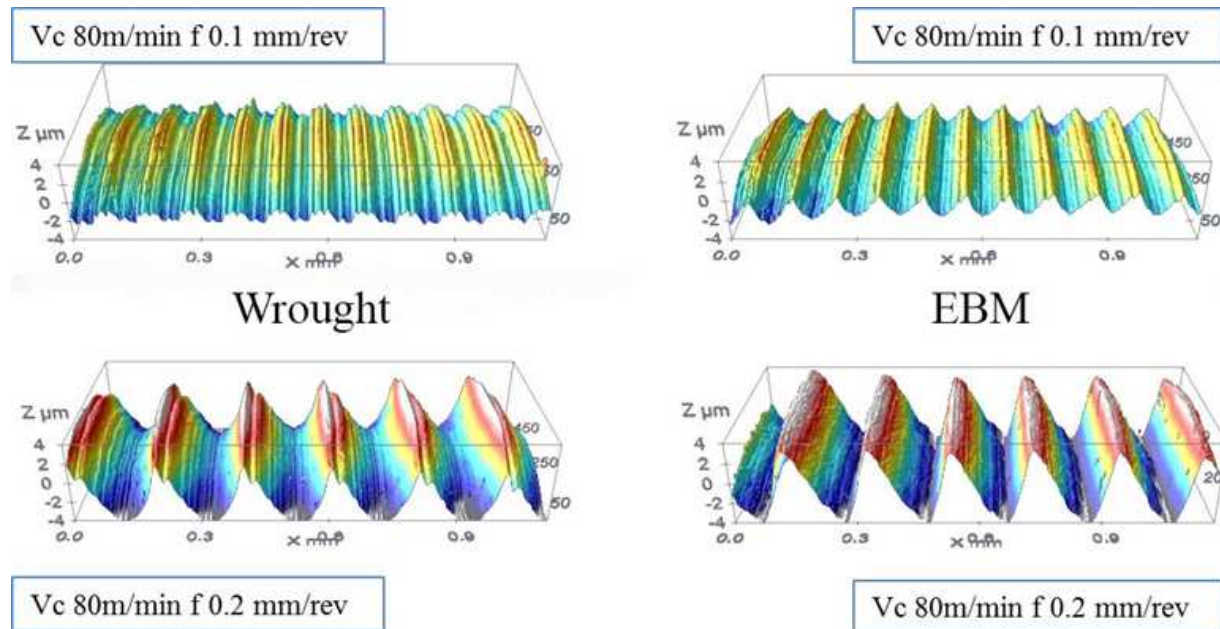
Surface topography– EBM vs. wrought

- The tool wear did not affect the surface profiles for both the alloys and for all the cutting conditions
- Material side flow and deformation along the feed marks were observed for all the cutting conditions
- Double feed marks generated at a feed rate of 0.1 mm/rev , due to the lower chip thickness
- The increase of the feed rate resulted in a better surface topography due to the higher chip thickness and less smearing aside of plastic material under the tool nose

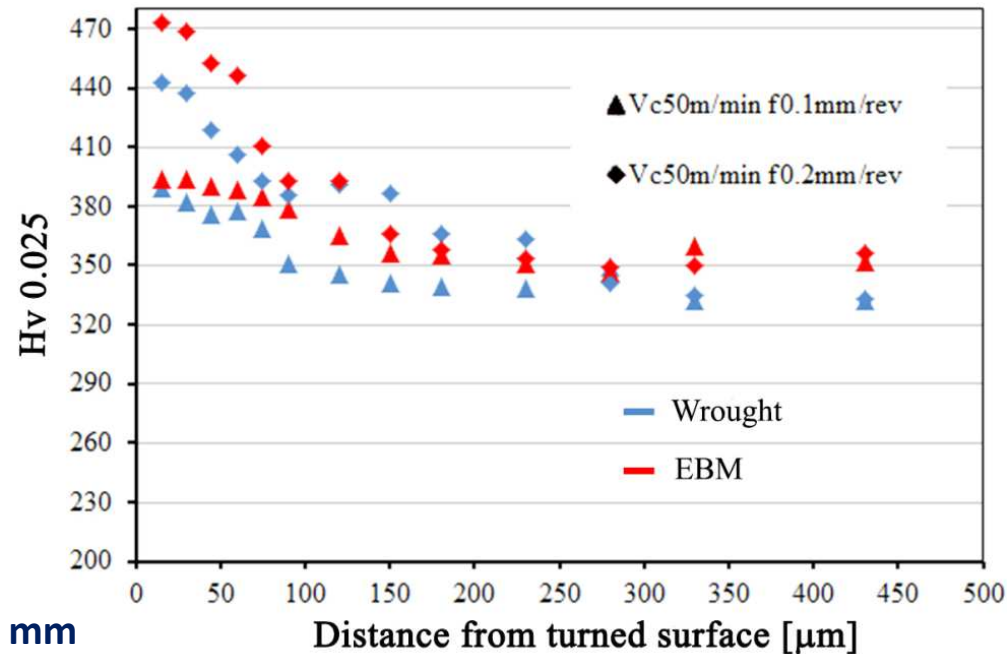
Micro-hardness– EBM vs. wrought

At VBc 0.1 mm

- Surface hardening along a radial direction was observed for both the alloys and cutting conditions
- Up to 100 hardness increase was measured for a feed rate of 0.2 mm/rev for both the alloys
- Higher levels of surface micro-hardness was measured at increasing cutting parameters, although the effect of the cutting speed was almost negligible

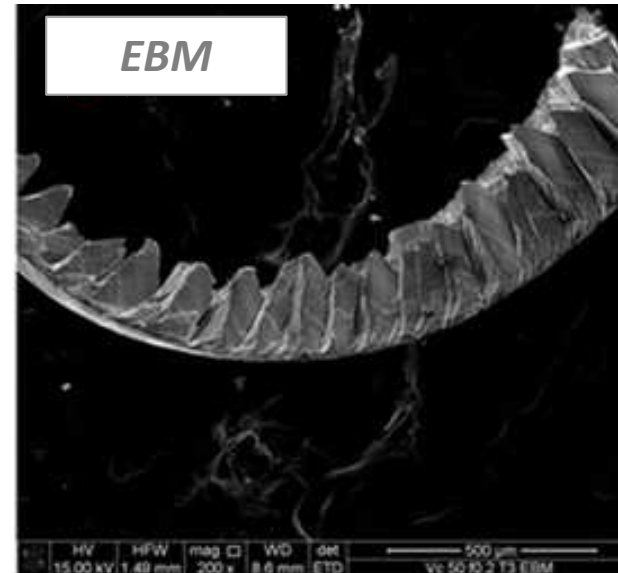
Chip morphology – EBM vs. wrought

- **Segmented chip** resulted for all the cutting conditions when turning the wrought Ti6Al4V
- At increasing the cutting parameters, in particular for a feed rate of 0.2 mm/rev, the chip of the wrought Ti64 was more periodic
- The EBM Ti6Al4V saw tooth chip was more sensitive to the cutting parameters and at the initial stages of turning adopting a cutting speed of 50m/min and feed 0.1 mm/rev a transitional chip was observed

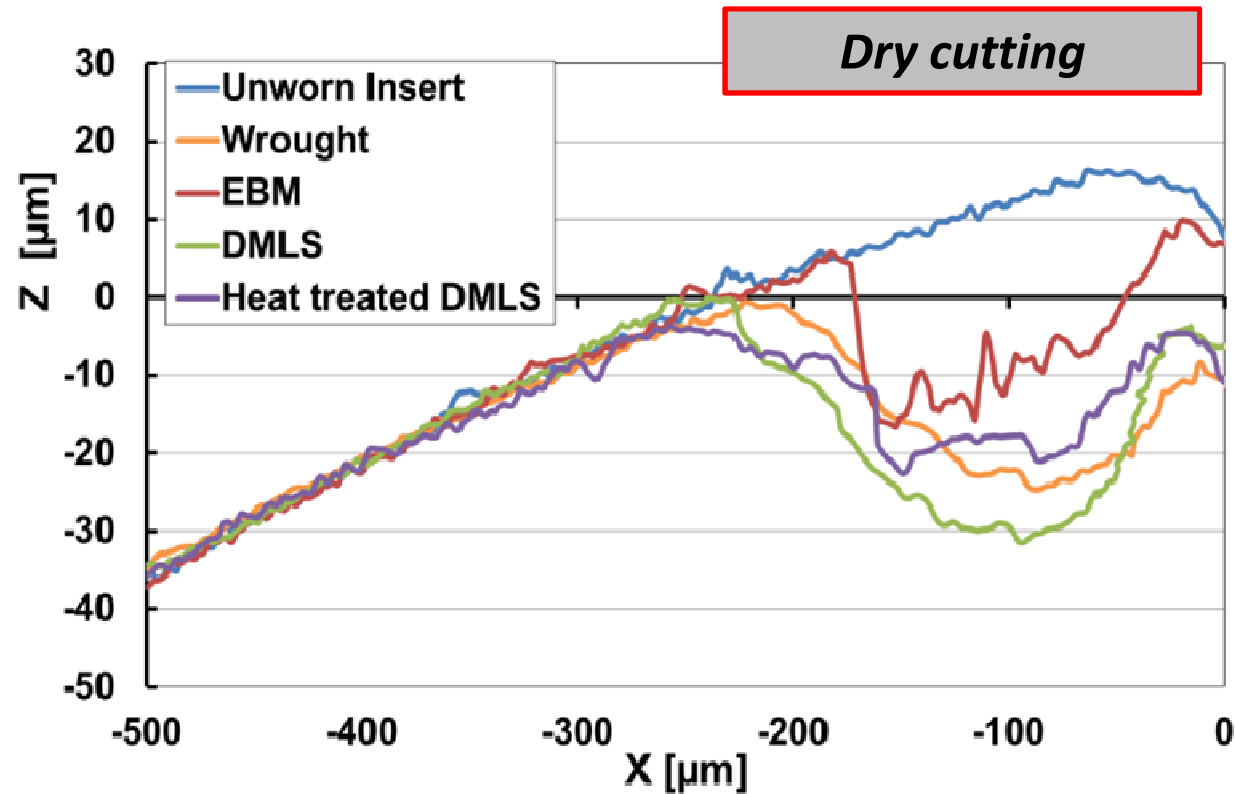
Crater wear /1

- ✓ Cratering always present regardless the Ti6Al4V microstructure under dry cutting, the worst when cutting the as-built DMLS material

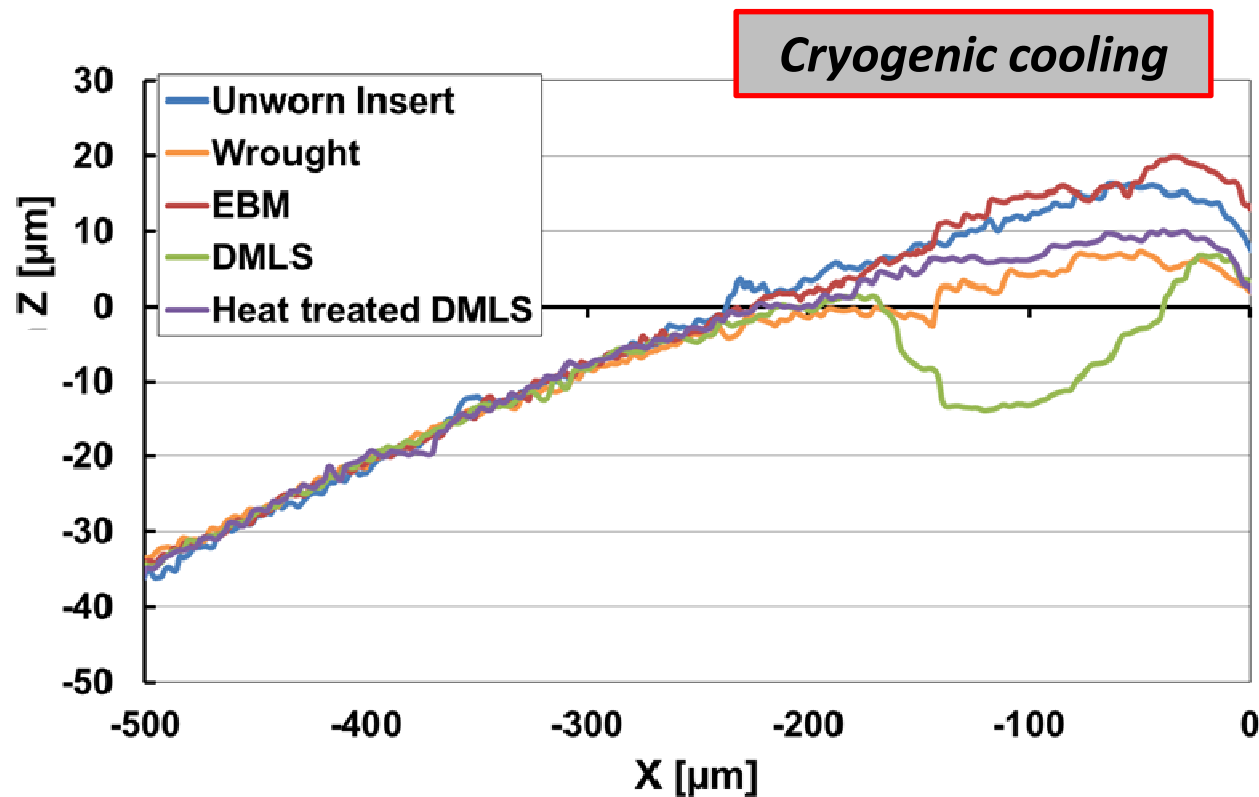
Crater wear /2

- ✓ Cryogenic cooling strongly reduced the cratering, being completely eliminated when cutting the EBM material, but still significant when cutting the as-built DMLS

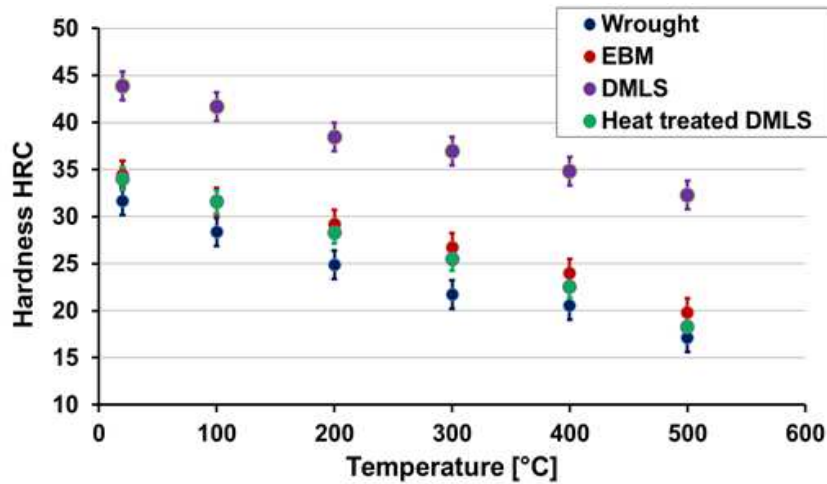
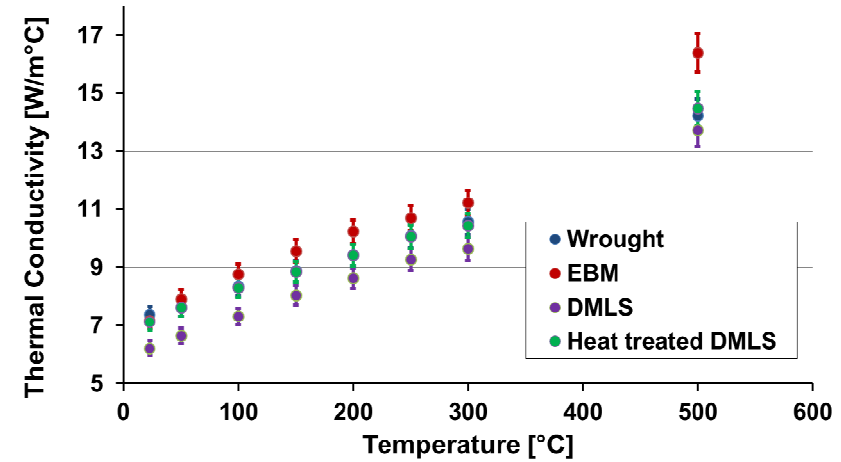
Discussion

→ Correlation between the mechanical and thermal characteristics of the Ti6Al4V microstructures *at varying temperature* and the tool wear mechanisms

Dry cutting	As-built DMLS	↑↑ Hardness → ↑ Abrasion	↓↓ Th conduc → ↑ Diffusion	↑↑ Crater wear
	EBM	↓ Hardness → ↓ Abrasion	↑↑ Th conduc → ↓ Diffusion	↓ Crater wear
Cryogenic cooling	As-built DMLS	↑↑ Hardness → ↑ Abrasion	//	↑↑ Crater wear

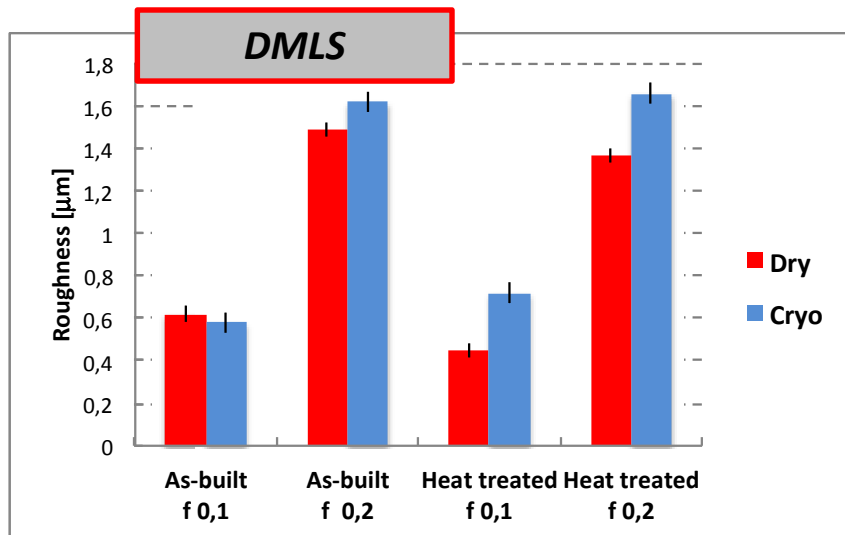
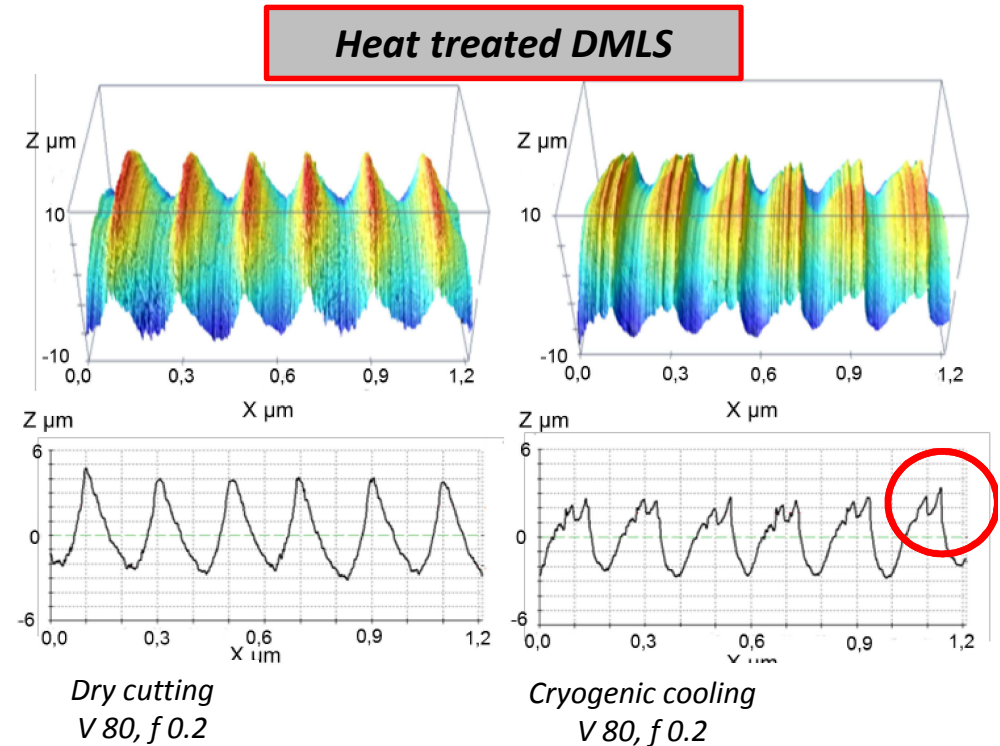
Surface topography – DMLS vs. ht DMLS

- ✓ Lower surface roughness in case of dry cutting for the heat treated DMLS compared to the as-built DMLS
- ✓ Slightly higher surface roughness in case of cryogenic cooling for the heat treated DMLS

- ✓ Cryogenic cooling produces a more discontinuous surface compared to dry cutting
- ✓ Presence of double feed marks in cryogenically machined samples

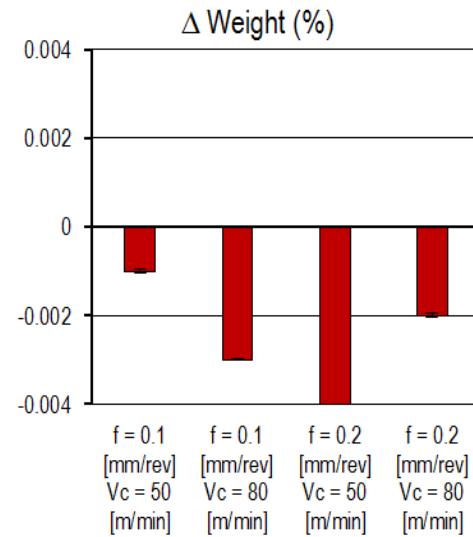
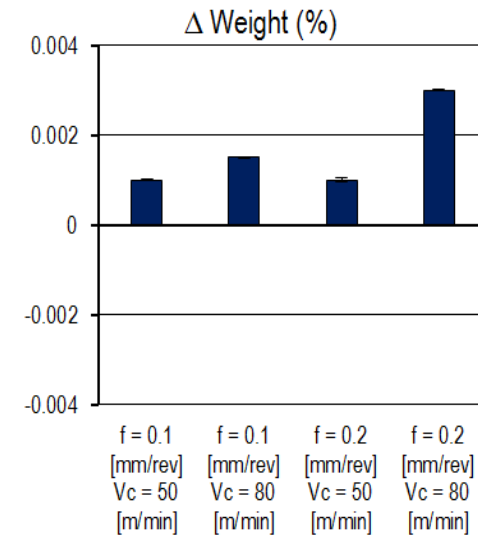
Reciprocating sliding wear /2

- ✓ Wider and more fragmented scars under dry cutting conditions
- ✓ Severe adhesion of the flat plate material protects the pins against further abrasion in the case of cryogenic machined pins
- ✓ Worn cryogenic machined pins increased in weight due to the adhered flat plate material

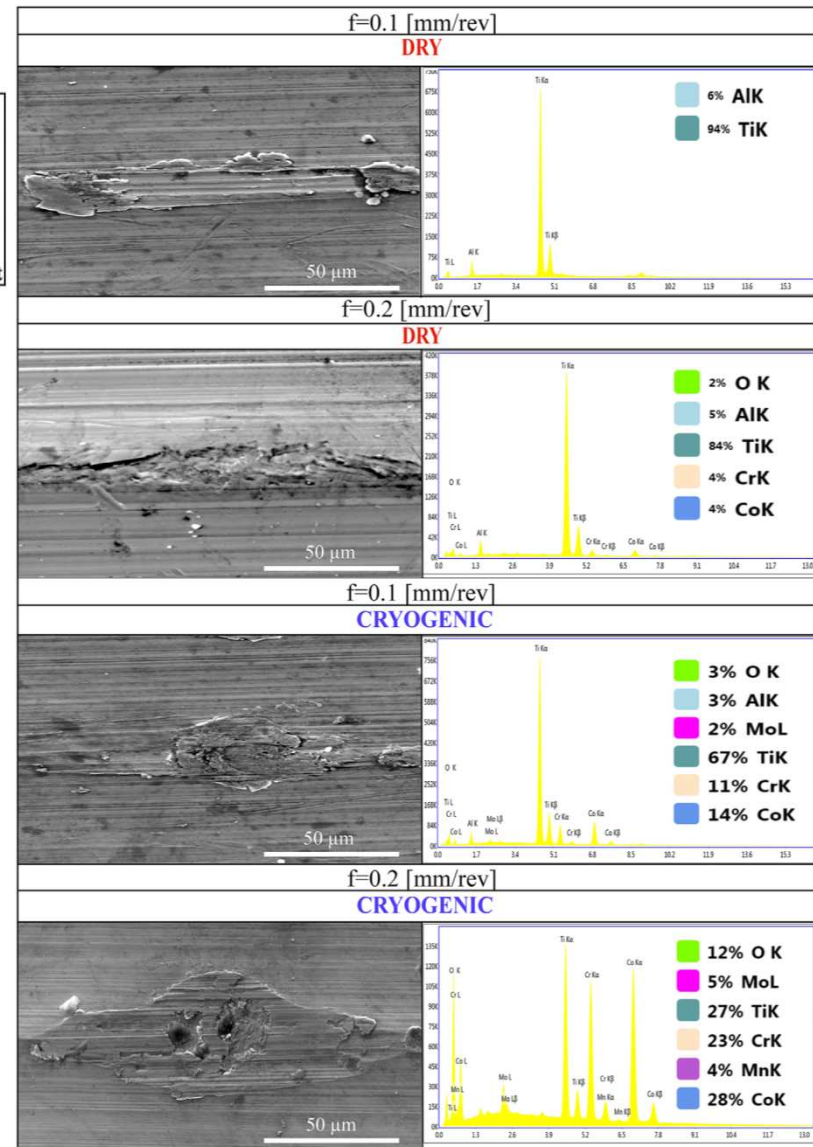
Fretting

- ✓ Cryogenic samples show lower corrosion potential than the dry ones
- ✓ Higher adhesion of the counterpart material on the cryogenic samples
